Compost use for geotechnical stability of engineered slopes, erosion control and restoration of riparian habitats.

3rd Progress Report September 2009

Written by: Dr Robin Davies BSc PhD CSci and Mike Palmer BSc MSc

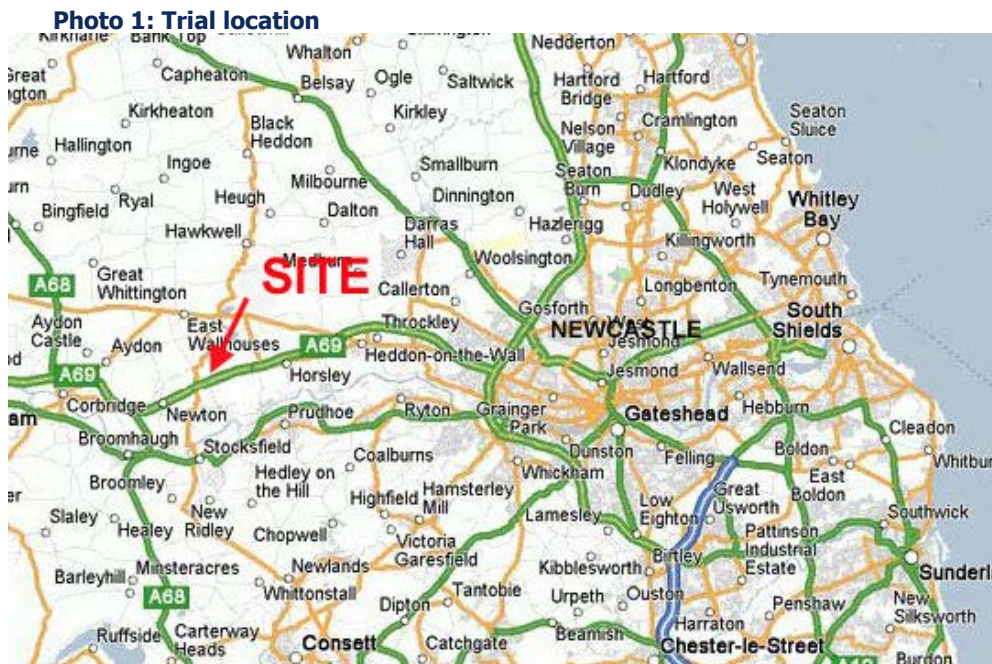
The experimental site is located at Nafferton Farm, near Hexham, Northumberland. The trial is being conducted on a purpose-built artificial embankment constructed by the University of Newcastle upon Tyne. The embankment is 90 m long, 29 m wide and 6 m tall and is made of sandy clay of medium plasticity well compacted according to modern construction standards. The embankment is orientated east to west, providing maximum contrast of microclimatological conditions between north and south facing slopes.

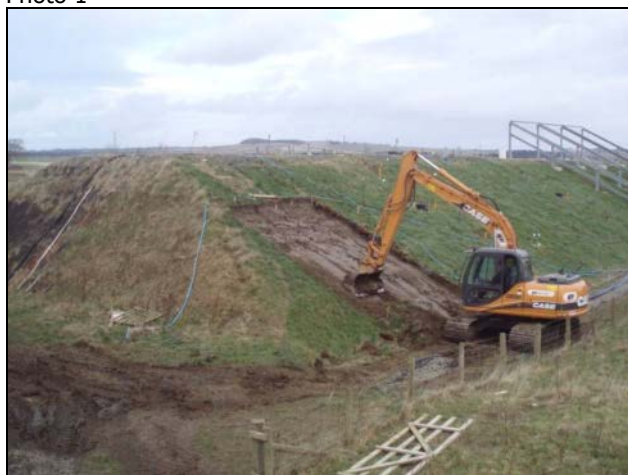
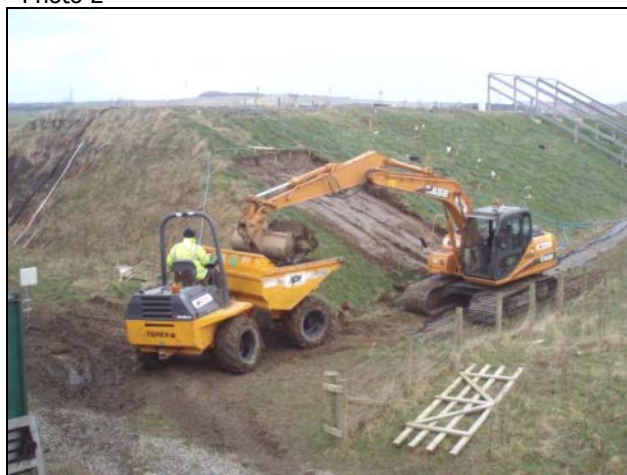
Photo 1

Plot areas were established in four 6 x 9 m replicate blocks at either end of the embankments on both the north and south facing slopes. Plot construction firstly involved removing the topsoil using an excavator on the current slope to simulate the surface of a typical newly established unvegetated slope within an infrastructure project (Photos 1 and 2).

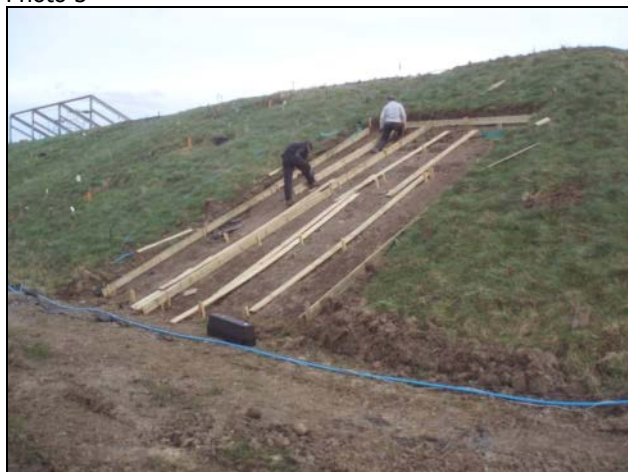
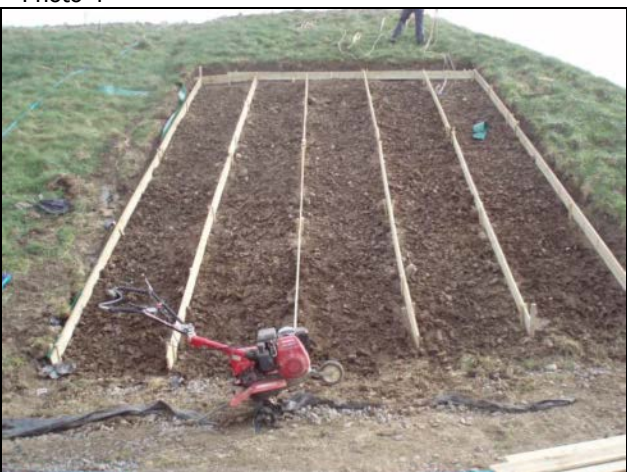
Photo 3

Following topsoil removal, wooden plot borders were inserted (Photo 3) and the surface was scarified with a rotavator (Photo 4). This simulates the degree of surface preparation recommended as per CIRIA report *The Use of Vegetation in Civil Engineering* (Hardcover) by N.J. Coppin (Editor), I.G. Richards (Editor). Construction Industry Research & Information Association (CIRIA) (Mar 1990). Each plot measures 1.2 x 9 m.

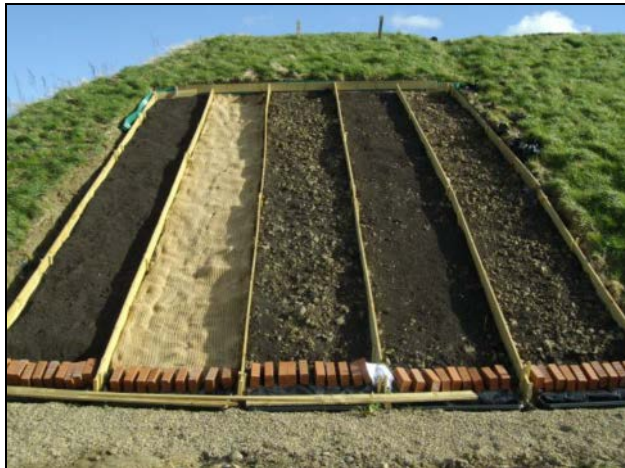
Photo 7 NE corner

Runoff collection troughs were dug in to the base of each plot following treatment application (see photos 7-10). Final preparations included a bentonite clay seal along the outside of the top border to prevent water movement into the plot from above and a loose brick placement at the base to prevent slumping into the runoff collection troughs.

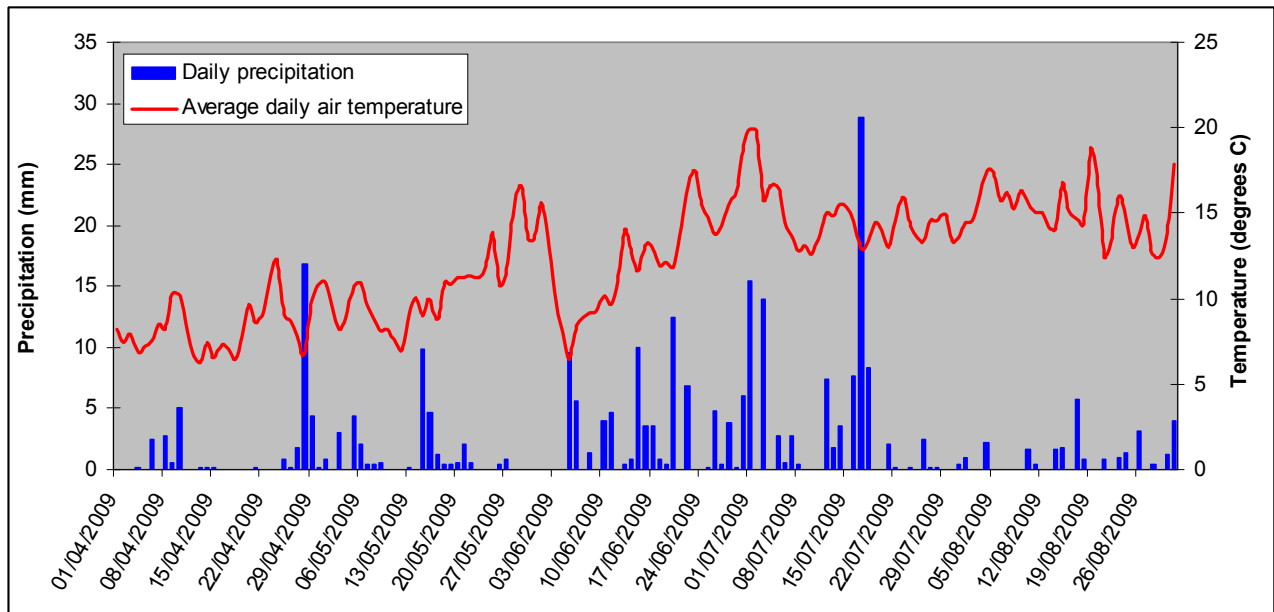
Figure 1. Rainfall and temperature data April-August 2009

The monitoring period during 2009 has included a period of unusually wet weather from late June to mid July. This included a large storm event on the 16th and 17th of July when 36 mm of rainfall fell within a 24 hour time period.

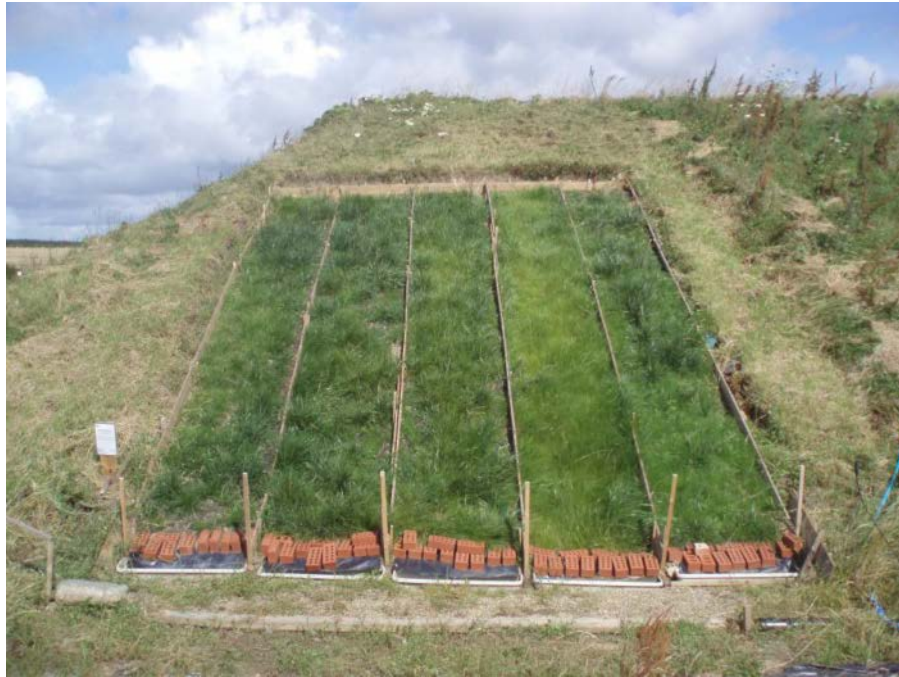
Photo 11. South west block. Treatments left to right: 10 cm incorporated; 5 cm surface; 5 cm incorporated; geotextile.

The effects of increased fertility due to compost application can be seen in the differences in grass yields (Table 4) and are also illustrated in Photos 11-14 taken on July 30th 2009. While the results demonstrate the major effect of slope aspect on soil moisture content and resultant grass growth, the treatment comparison on the north facing slopes suggests significant increases in growth as a result of compost addition. Yield increases appear proportional to the compost application rate.

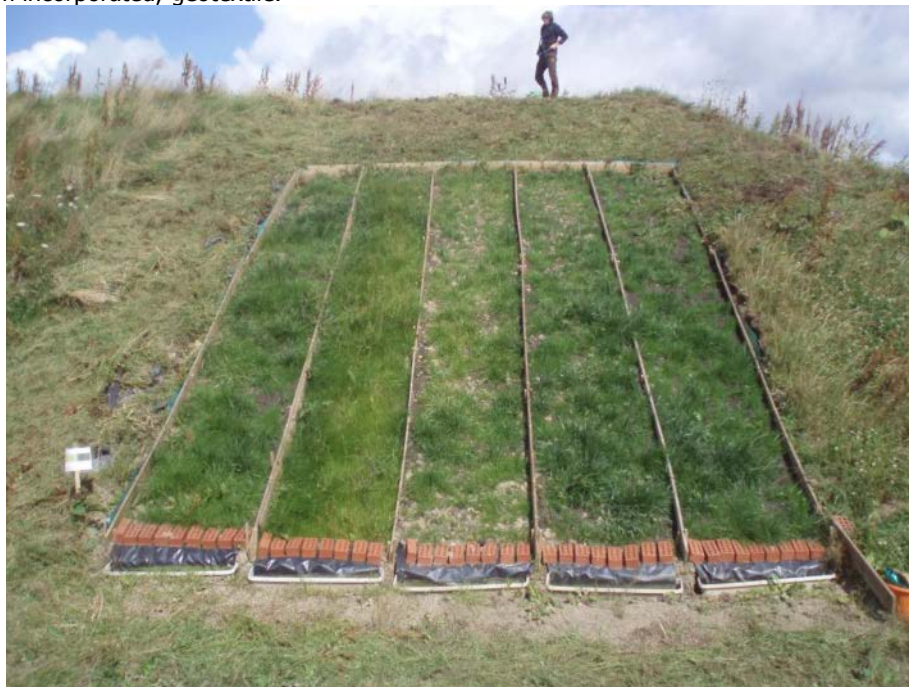
Photo 12: South east block. Treatment left to right: 5 cm surface; geotextile; 5 cm incorporated; 10 cm incorporated; 10 cm surface.

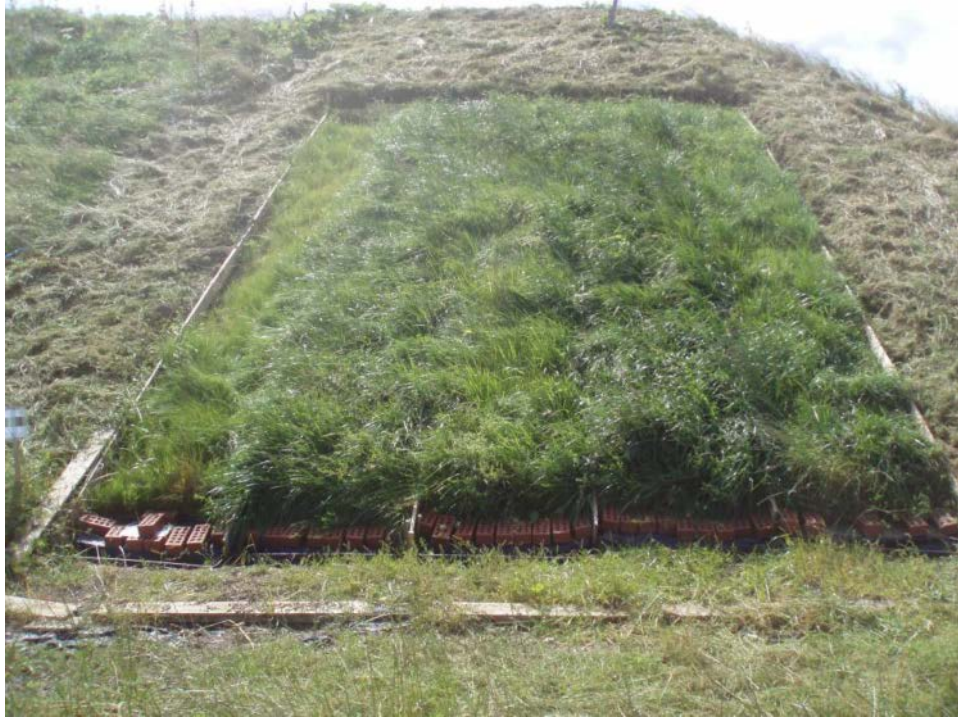
Photo 13: North west block. Treatments left to right: goetextile; 10 cm surface; 5 cm surface; 10 cm incorporated; 5 cm incorporated.

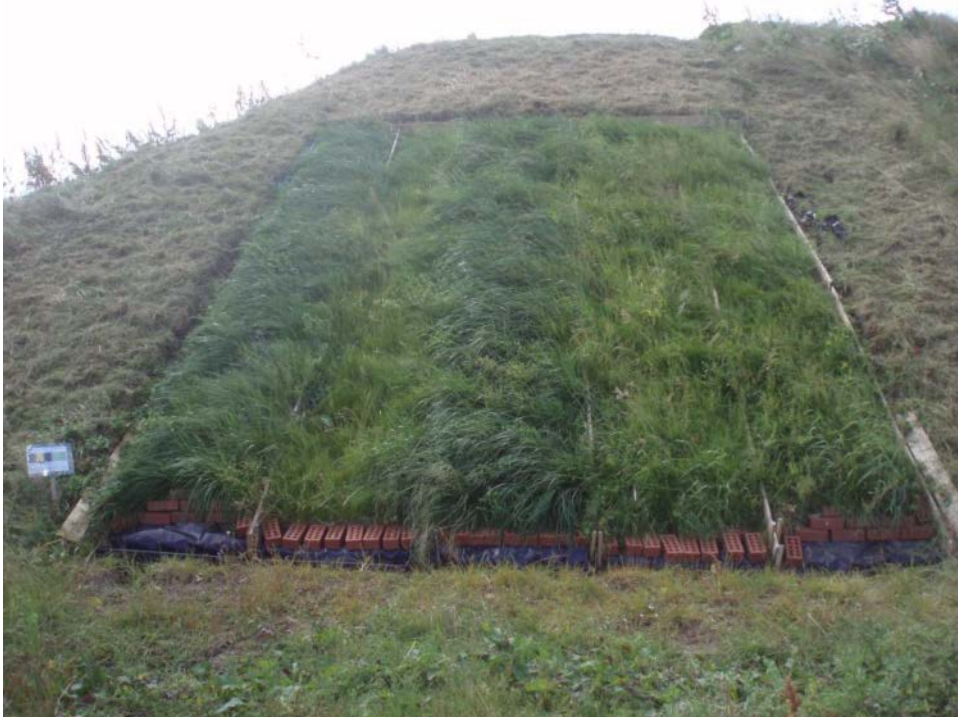
Photo 14: North east block. Treatments left to right 10 cm surface; goetextile; 10 cm incorporated; 5cm surface; 5 cm incorporated.
